Inspection Report Minerals Regulatory Program

Mine Name: Sunset (Rainbows End)
Operator Name: Steven Delong

Permit number: S/053/032

Inspection Date: February 14, 2007

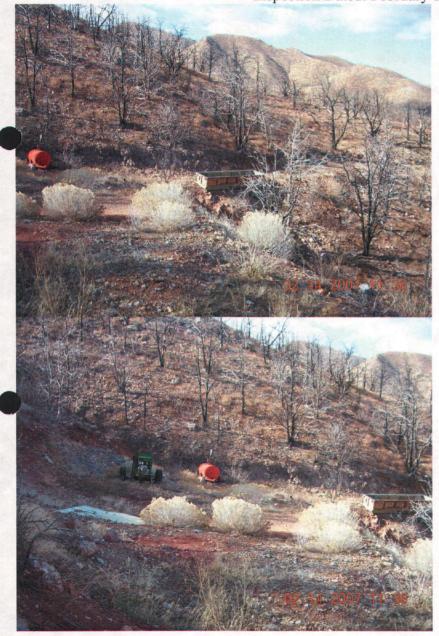
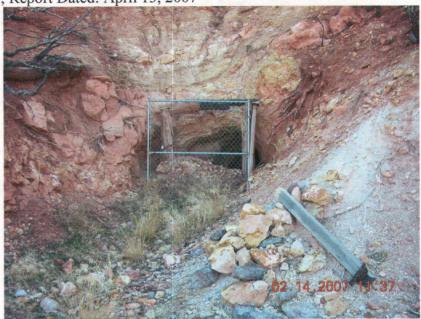
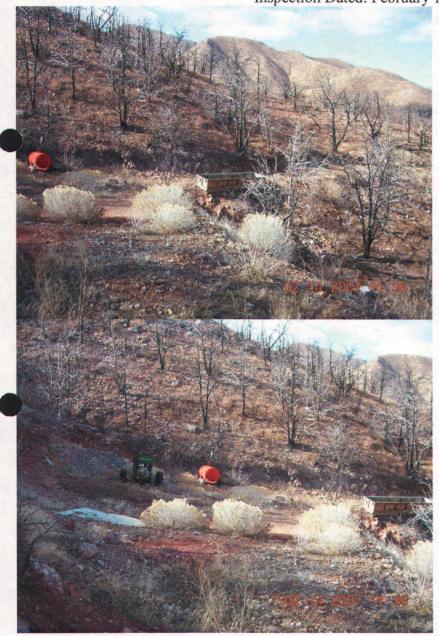
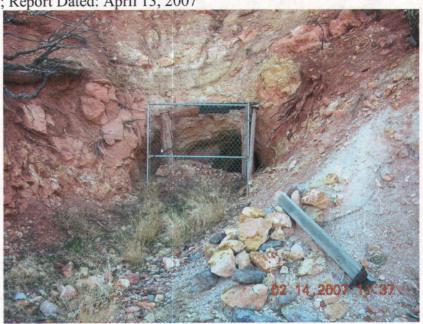
There were four-wheeler tracks going into the mine site, but other than that there had been no recent activity at the site. There is an open portal and a small dump. Equipment left on the site include, a portable generator, a fuel tank and a large aluminum bin.

Since the site has been in suspension for a number of years, it should probably be cleaned up and closed. The equipment should be hauled out and the portal sealed. The small dump could be pulled back and the pad area eliminated. The access road is primarily self-reclaimed. There are some areas that may need some regarding and seeding, but this probably depends on the amount of re-disturbance that would occur when accessing the site for reclamation. Photos of the area were taken.
